Astra Tech Implants: Anyone Else Experience Flowering in the Top of the Implants?

I have been using Astra Tech implants quite successfully for some years now. Recently I have had several cases of Astra Tech implant fixtures experiencing a flowering [Editor's note: fracturing within the coronal aspect]. I have just seen my third case of this happening in their 4.5mm diameter implant. The case involved screw retained crowns that had been functioning without any problems for 3 years. Could this have been due to an occlusal overload? Or is this a problem in implant design or flexural strength? I discussed this problem with Astra Tech and they say that this has been a rare event. Have any of you experienced this problem with their implant system?

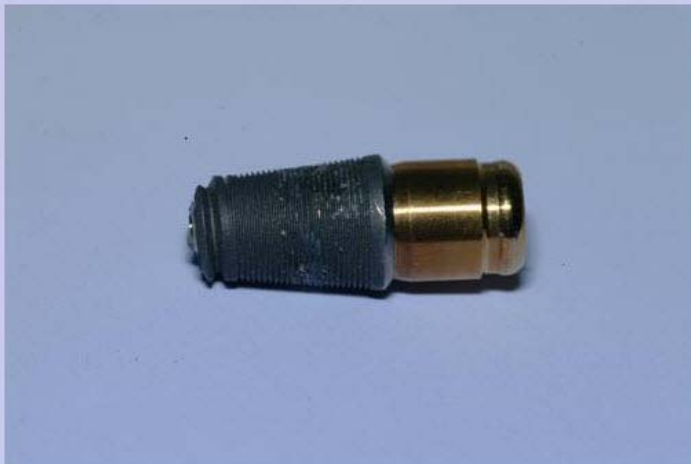
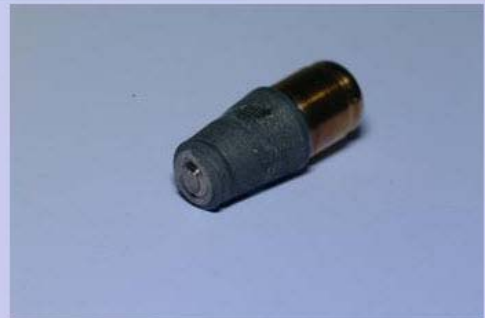
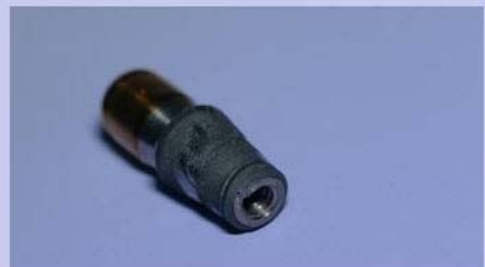
Fracture of Astra Implant. If Micro-threads had preserved bone, then there would be no lateral force 4mm below crest

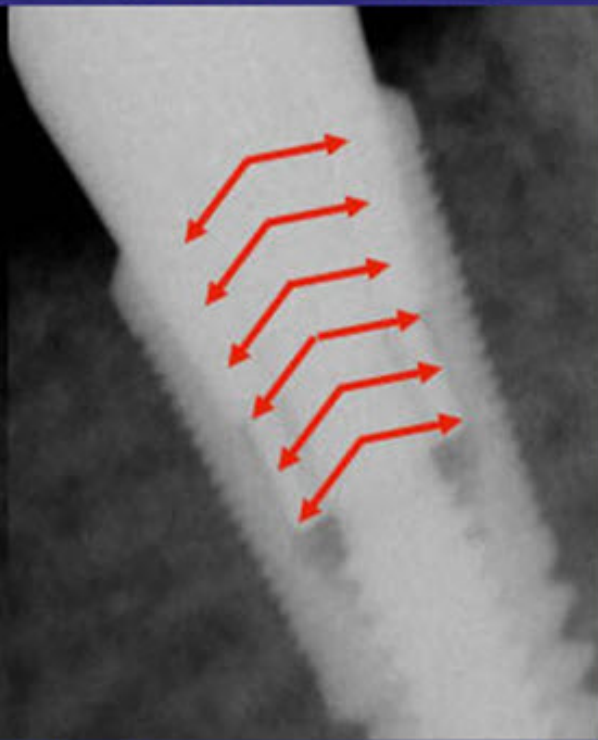
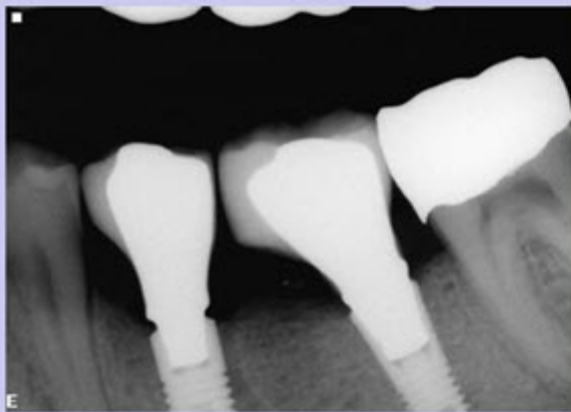
Astra Implants – Deep Conical Connection/Thin Walls 3/08
